CLAWAR 2018: 21st International Conference on Climbing and Walking Robots and the Support Technologies for Mobile Machines, Panama City, Panama, 10-12 September 2018

## **DEVELOP A SENSOR BASED ROBOT FOR RAILWAY INSPECTION**

This project produced a sensor based robot capable of testing a section of railway track, using both magnetic flux and visual inspection. Surface quality inspection is performed by a probe consisting of a number of Hall effect sensors. Visual inspection is performed by a camera connected to the robot. A replica rail section was also created for the purposes of calibrating and demonstrating the robot. The hardware and software developed successfully collected video data and magnetic flux readings. The output of the hall effect sensor array was processed in MATLAB producing a heat-map. The shape and depth of artificially induced defects were successfully displayed.

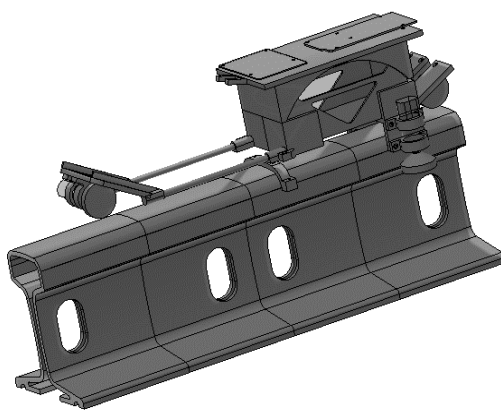
Figure 1a – Assembly of Robot and Track

This used wheels on the top and sides of the rail to travel across one rail and perform an inspection. This design supported visual and magnetic flux inspection with the optimal cost, time and materials usage.

The platform was designed to enable movement across the rail and contact between the rail and the sensor array. A single rail crawler design was selected.

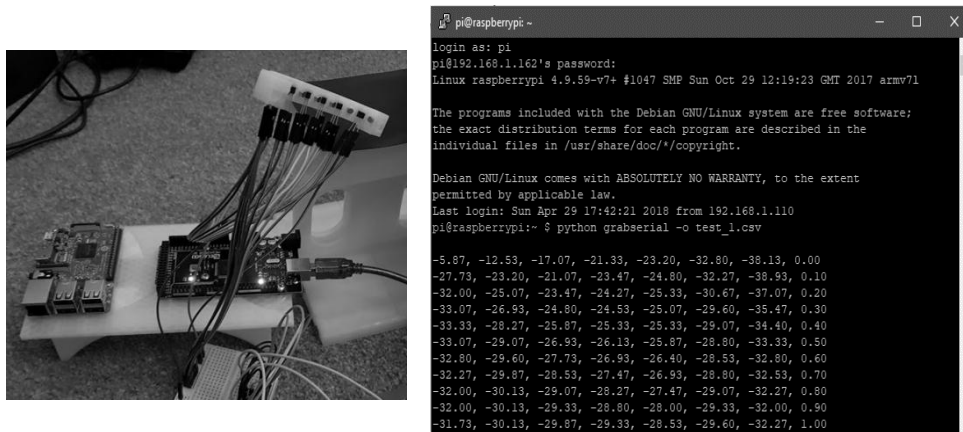
The Raspberry Pi was instructed to collect video and serial data using the command line over SSH. The video was collected using the raspivid command. The serial data was collected using the grabserial library.

Figure 3 - Using the Grabserial Command to Collect Data from the Arduino
